Tech Tip

EMISSION CONTROL 122

CRANKCASE VENTILATION Yesterday's Technology Poses Some New Challenges

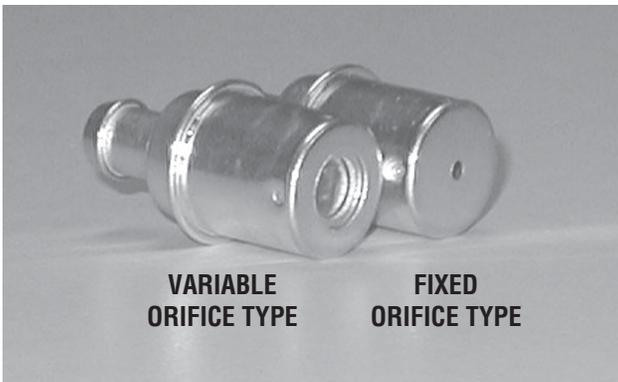
Assuming that the basic checks and considerations have been satisfied, GM recommends installing a revised PCV valve. It has been determined that under certain operating conditions, the original equipment variable type PCV valve flow rate may promote excessive oil consumption. The original equipment valve may promote a siphoning of the oil back into the intake manifold where it would be consumed through the combustion process. Examine the hose that attaches the PCV valve to the intake manifold for evidence of an excessive amount of oil. If excessive oil is present, GM recommends installing a revised PCV valve. The new style valve (GM #12572717, Mighty #3-932) is a fixed orifice valve with no moving parts (see illustration). The valve will not rattle when shaken. It is basically a shell of the OE style valve with an approximate .100

inch hole drilled in the bottom of the valve, providing a fixed flow rate. When servicing, technicians must be aware of the factory modification and be certain not to install the same type variable orifice valve that originally came on the vehicle. Doing so would reintroduce the performance condition that was corrected with the fixed orifice design.
