TROUBLESHOOTING BELT NOISE

Installing a Second Belt Is Not the Solution

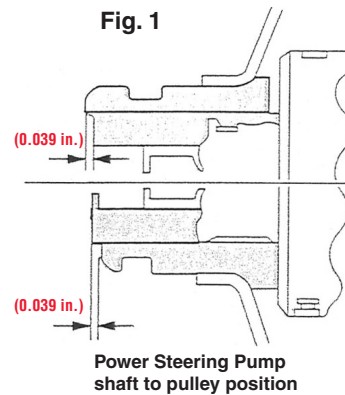
For a belt noise condition, the first check should involve a belt-to-pulley alignment check. Verify that the power steering pump pulley is pressed onto the pump shaft in the proper position. While the pulley should be flush with the end of the pump shaft, it can be repositioned on the shaft to achieve the proper belt alignment. The pulley to shaft position variance should not exceed 0.039 inch from the end of the pump shaft (see Fig. 1).

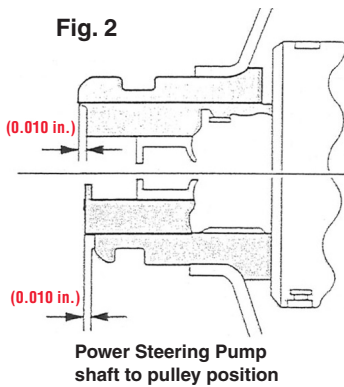
GM's Noisy Gas Burners... The position in which the power steering pump pulley is pressed onto the pump shaft has been an issue with GM applications. GM has acknowledged that 1996–98 Chevrolet and GMC trucks C/K, M/L, S/T, G and P Models, and 1996–1998 Olds Bravada with 4.3L, 5.0L, 5.7L and 7.4L engines may encounter drive belt noise due to the position in which the pump pulley is pressed onto the power steering pump shaft. Positioned incorrectly, the belt will be misaligned,

resulting in belt noises. The spec calls for the pulley to be flush with the end of the pump shaft. If the belt is not properly aligned with the pulley in this position, GM advises that the pulley should be repositioned on the pump shaft with a maximum variance of 0.010 inch from the end of the pump shaft (see Fig. 2). Notice how the pulley

to shaft position differs from the previously mentioned Duramax Diesel illustrated in Fig. 1.

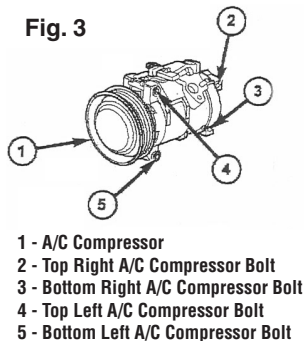
Chrysler Pacifica... Chrysler acknowledges that a belt chirping or squeaking condition may be present on the 2004–2005 Pacifica with the 3.5L engine, due to misaligned pulleys. The noise may be present when first starting the engine, while idling after the warm-up, or while driving at higher engine speeds. The first step involves examining the power steering pump pulley to determine if it is flush with the end of the pump shaft. If not, it will be necessary to reposition the pulley. In order to attach a puller to the power steering pulley, it will be necessary to loosen and raise the engine a few inches from its mounted position. This requires attaching an engine support fixture to the left top side of the engine.

- 1 - A/C Compressor
- 2 - Top Right A/C Compressor Bolt
- 3 - Bottom Right A/C Compressor Bolt
- 4 - Top Left A/C Compressor Bolt
- 5 - Bottom Left A/C Compressor Bolt

If the noise is still present, Chrysler recommends a specific A/C compressor alignment and tightening procedure. The first step involves loosening the A/C compressor bolts from the mounting bracket and pushing the A/C compressor toward the rear of the engine. While holding the compressor with one hand, tighten the bolts to 25 ft. lbs. in the sequence illustrated in Fig. 3 (top right, bottom right, top left, bottom left). Once this has been completed, start the engine and determine if the squeaking noise is still present. If so, with the engine off, loosen the A/C compressor bolts, push the compressor toward the front of the engine and tighten the bolts as previously illustrated.

Torque compressor bolts to 25 ft. lbs. in sequence illustrated
