Tech Tip

BRAKES 146

SIMPLE SOLUTIONS For Some Perplexing Brake Problems

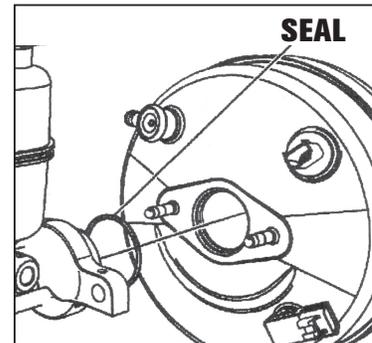
With the assistance of a GM dealership technician, the reason for the lean fuel trim was identified. Once the technician determined the MIL lamp illuminated following the replacement of the master cylinder, he quickly pinpointed the cause of the lean fuel condition. While monitoring the long term fuel trim with a scan tool and encountering a lean condition, he pinched the power brake booster vacuum hose with a set of crimping pliers. When he did this, the fuel trim returned to normal. A vacuum leak had occurred between the master cylinder and the power brake vacuum booster due to a dislodged seal (see illustration).

When replacing the master cylinder, the vacuum reserve in the power brake booster should be depleted by applying the brake pedal several times with the engine off. This will prevent the seal from being sucked into the booster when removing the master cylinder.
