Tech Tip

FILTERS 148

FILTER SOLUTIONS For Some Challenging Conditions

GM'S DURAMAX FUEL FILTERS

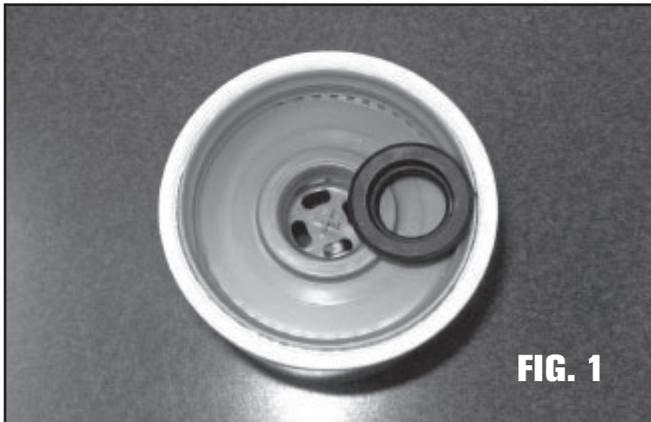
A second condition involves technicians complaining of a difficult fuel filter installation. A frequent complaint is the filter will not thread onto the filter adapter. The installer is usually certain that damaged filter housing threads are the reason for the installation difficulty. The culprit is usually a grommet from the previous filter that is still attached to the filter adapter, making it impossible to install the new filter (see Fig. 1).

Check for detached filter grommet.

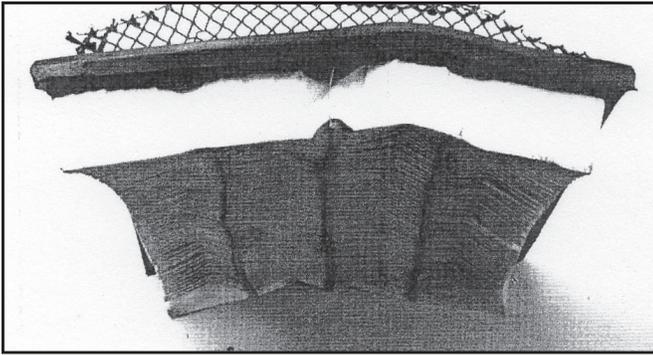
FIG. 2

Water and snow are not good air filter companions, especially for turbocharged diesel engines. Either can destroy a lot of expensive parts very quickly. The filter illustrated in Fig. 2 was removed from a Dodge Turbo Diesel that ingested road splash. The water sealed the filter media and the filter was almost pulled from the air box housing. Obviously, the filter lost its seal with the housing, allowing debris to be sucked into the turbocharger and engine. Fortunately, the

filter remained intact and was not shredded, which could have caused major mechanical damage. Snow entry can promote the same scenario. Following are modifications made by Ford and GM to alleviate snow related filter restrictions:

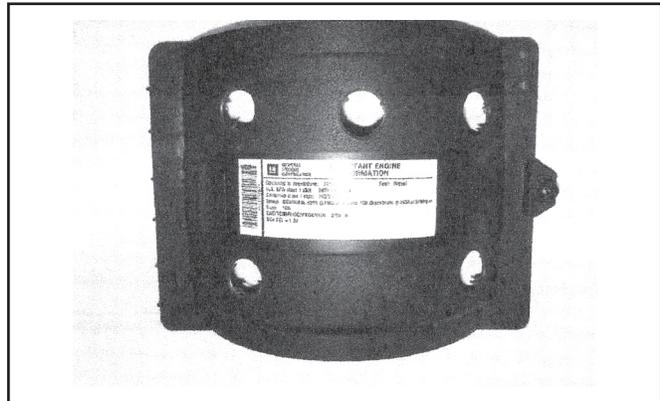
FIG. 3

GM's Duramax... GM advises that some owners of 2007–2009 Chevrolet Silverado and GMC Sierra 2500/3500 series vehicles may complain of an illuminated Check Engine light with diagnostic trouble code P0101 (mass air flow sensor performance) stored in memory as a history code or current event, and a Reduced Power Message on the DIC. These conditions are the result of snow being ingested into the air cleaner housing and restricting the engine's intake air.

GM recommends purchasing a new air cleaner cover P/N 20821430 and drilling five 25mm holes in the cover as shown in Fig. 3. Install emission label GM P/N 19180225 on the modified cover as shown. Remove the existing air cleaner cover and replace it with the modified cover. Retain the original cover for summer use. A grill opening cover, GM P/N 25822811 for GMC and P/N 25822812 for Chevrolet, should be installed as part of the repair. This modification allows warm air to be circulated into the air cleaner housing, which melts the snow.
