Tech Tip

OIL PRESSURE 186

CONTROLLING OIL PRESSURE It's a Matter of Regulation

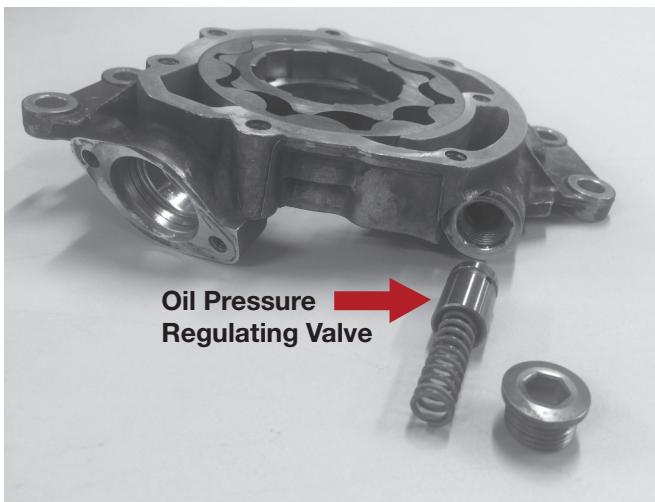
Sticking Pressure Regulating Valve...The following illustration reflects a typical GM crankshaft driven oil pump. A sticking pressure regulating valve has been a common occurrence, most often resulting in a loss of oil pressure.
