On the Line

Troubleshooting Oil Filter Housing Leakage What to Know About Chrysler's 3.6L Pentastar Engine

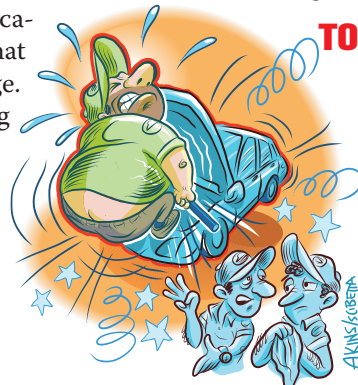
LIONEL LIKES THEM CAPS NICE AND TIGHT.
THE PROBLEM IS, THIS IS THE THIRD HOUSING
HE'S ABOUT TO DEMOLISH IN LESS THAN A WEEK.

Some vehicle owners have been falsely told that aftermarket oil filters would damage the oil filter housing, and others have advised that over-tightening the oil filter cap would crack the housing. We agree that over-tightening the cap could damage the housing and each shop owner/service manager must caution their lube techs not to over-tighten the cap when changing the filter.

While there has been no documentation that over-tightening the oil filter cap has resulted in the damage to the housings illustrated in the Chrysler Service Bulletin, it is of major concern. The cap is stamped with a torque spec of 25Nm (18 ft. lbs.). Over-tightening the cap can result in damage to the oil filter/cooler housing in the form of cracks, or disturbing the housing O-rings, resulting in leakage. Torqueing the cap can save hundreds of dollars in unnecessary repairs.
