Tech Tip

ELECTRICAL 128

SOLVING ELECTRICAL PROBLEMS Check the Integrity of the Connections

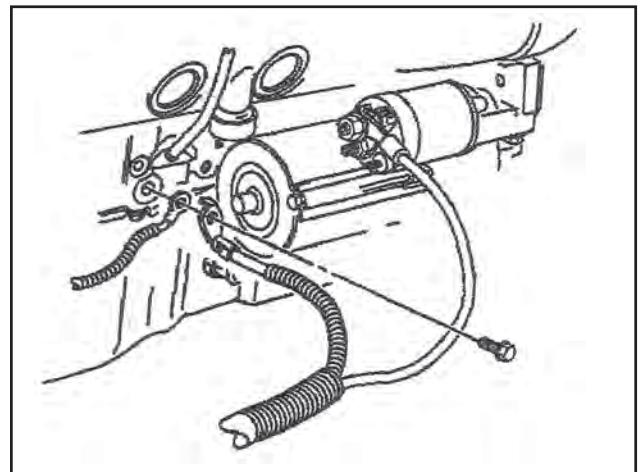
Symptoms involving a no-start or crank condition may be encountered on 2004 Buick LeSabre, Park Avenue/Ultra and Pontiac Bonneville vehicles (3.8L Vins 1,K) due to inadequate grounding of the starting circuit. GM

acknowledges that a condition exists whereby a ground point on the engine block may not be tapped deep enough into the block to provide adequate tightening of the ground cable attaching bolt (see illustration 1). The problem ground point is located forward of the starter motor. The bolt bottoms out in the block before it secures the ground terminals to the casting. The installation of a shorter bolt P/N 11517862 will be necessary to achieve adequate torque on the attaching ground cables. Some technicians will just add washers to compensate.

ILLUSTRATION 1
ENGINE BLOCK GROUND CIRCUIT G101

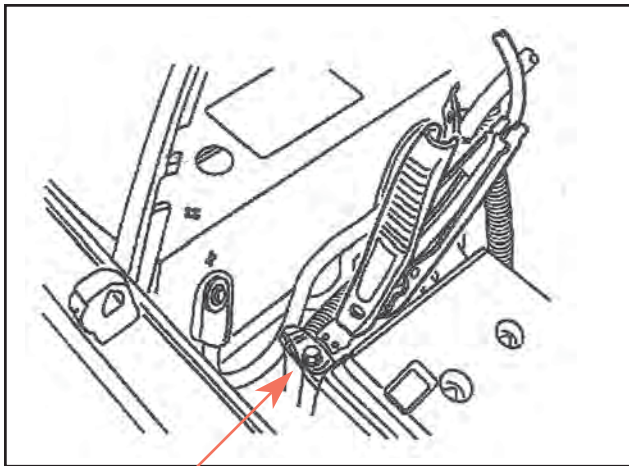
Portable booster packs are commonplace among the vehicle dealerships and independent car dealers. Special precautions must be taken when boosting a vehicle to prevent damage to the vehicle or the person attaching the equipment. Convenience of attachment becomes an issue when boosting a discharged battery. GM reports that some dealers may be utilizing the instrument panel battery positive stud located at the underhood fuse block to make the jump-start (see illustration 2). When doing this, the 125 amp mega fuse (#48) located in the engine fuse block may blow, resulting in a loss of power or damage to various electrical components inside the vehicle. To properly jump-start the vehicle, always attach the positive booster cable clamp to the positive battery terminal. The negative clamp should be attached to the remote terminal located on the front engine lift bracket, marked "GND". Vehicles affected include: 2004 Buick Rainier, 2002–2004 Chevy TrailBlazer, TrailBlazer EXT, 2002–2004 GMC Envoy, Envoy XL, 2004 GMC Envoy XUV, and 2002–2004 Olds Bravada vehicles.

ILLUSTRATION 2
DO NOT USE THIS TERMINAL TO JUMP-START
THE ENGINE

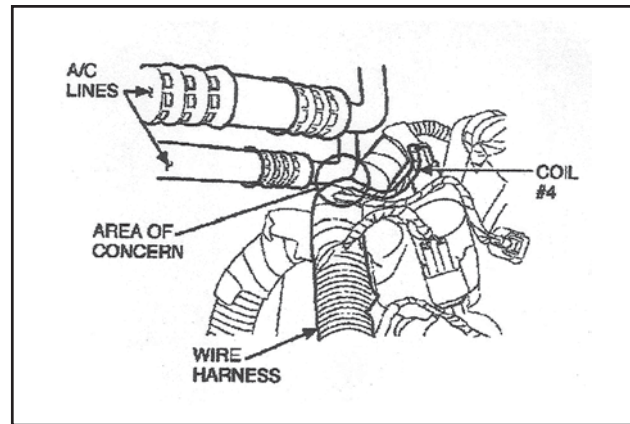
Ford has since experienced some ignition coil failures due to wiring harness routing issues. Ford acknowledges that some 2004 F150 trucks equipped with the 5.4L engine may encounter an illuminated Malfunction Indicator Lamp (MIL) and diagnostic trouble code PO354, which indicates cylinder #4 primary/secondary coil fault. Ford has addressed this problem and determined that a wiring related problem is the cause of this condition. The damaged wiring may be due to the air-conditioning line coming in contact with the wiring to #4 coil, from the main harness loom. Chafing of the insulation results in a short. Ford recommends re-routing the main harness loom by re-positioning the two harness retainers on the right hand side of the engine. Inspect both #4 coil electrical wires and the related harness connector (see illustration 3).

ILLUSTRATION 3
INSPECT COIL WIRING HARNESS FOR DAMAGE
