Tech Tip

BRAKES 132

Putting the Brakes on Elusive Brake Symptoms

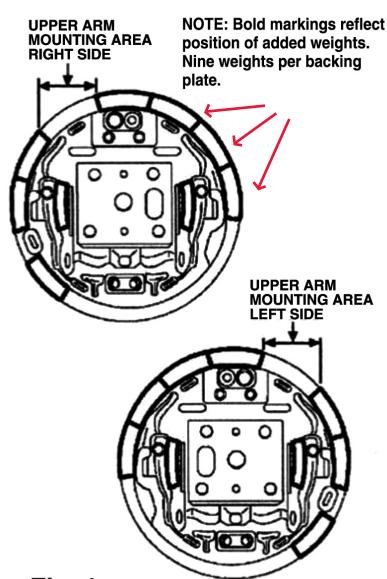
Fig. 1

This is a good example of a vehicle with an inherent condition that makes it impossible to solve a rear brake squeal symptom without some assistance from the vehicle manufacturer. Ford acknowledges that a rear brake squeal condition on the 2000–2005 Focus, equipped with rear drum brakes, may require a backing plate modification to eliminate brake squeal. Replacing the shoes and machining the drums will not resolve the symptom.

The noise condition is caused by a resonance traveling through the rear backing plates. To reduce the noise to an inaudible level, Ford recommends installing damping weights to the back side of the backing plates. This will be the opposite side of the backing plate from the brake shoes. Nine weights (P/N 5S4Z-1040-B) per backing plate (see Fig. 1) will be necessary to quiet

the resonance. A special adhesive (P/N 4U7Z-19B508-A) will be required to attach the weights.

The installation requires that the backing plates are thoroughly cleaned with brake cleaner in the area where the weights will be attached. Scuff the adhesion area with a scotch-brite pad and wipe the area with isopropyl alcohol. Once the weights have been placed into position with the adhesive, they should be secured with duct tape for a minimum of 15 minutes before reassembly. The adhesive starts to cure immediately; therefore the weights must be secured within one minute following the application of the adhesive. Allow a minimum of one hour cure time for the adhesive before driving the vehicle.

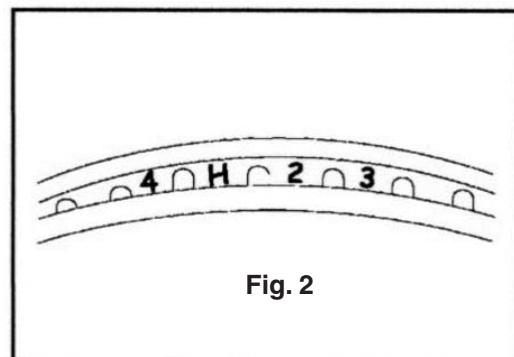
Fig. 2

Expedition/Navigator... If you are troubleshooting a front brake roughness or shudder condition on a 2004–2006 Ford Expedition or Lincoln Navigator, be advised that traditional procedures such as machining the rotors will not likely resolve the complaint. Ford advises that some 2004–2006 Expedition and Navigator vehicles built on or after 12/18/2003 may encounter a recurring brake roughness or shudder symptom during brake application. The date code on the rotor should be checked to determine if the vehicle has the new or old style rotors. The date code can be found on the edge of the rotor between the cooling fins, as illustrated (see Fig. 2).

- If the date code is prior to 4H23 (4=2004, H=August, 23=23rd) and the front friction is the low dust type, replace the front rotors (P/N 6L1Z-1125-A).

- b) New style caliper assemblies are also required (P/N 6L1Z-2B120-D, 6L1Z-2B121-D).
- c) If the date code on the rotor is 4H23 or higher, replace only the two front calipers. The revised calipers are pre-assembled and include anchor, springs and friction. The rotors should be machined with an on-car lathe, assuming they are within the minimum thickness specification.

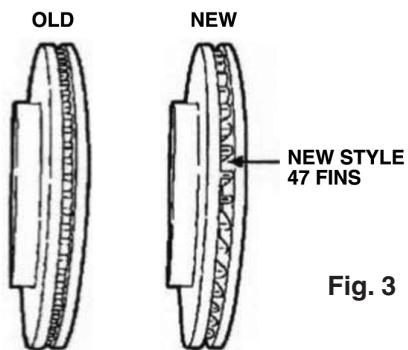
Ford F150... Ford states that some 2004–2005 F150 trucks built prior to 11/29/2004 may experience front brake roughness or shudder during braking. The following action will be necessary:

- 1) Trucks built prior to 8/20/2003 will require a new rack and pinion (steering gear) assembly.
- 2) Check the rotors to determine if the truck is fitted with new or old style rotors. The new style rotors contain 47 cooling fins (see Fig. 3).
- 3) If the old style rotors are present, replace both front rotors. A new spindle nut is required on 4x2 units.
- 4) If the new style rotors are present, machine the rotors with an on-car lathe.
- 5) Install Ford's revised pre-assembled/loaded caliper assemblies (see Fig. 3 for part numbers).

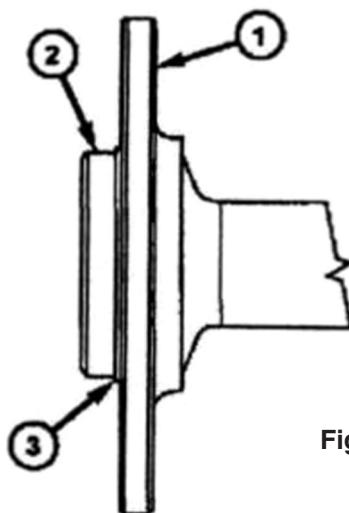
Fig. 4

If the owner of a Jeep Cherokee complains of a clunking condition from the rear brakes during brake application, the problem may be due to an improperly machined axle shaft. Vehicle year models include 1997–1999 Jeep Cherokees equipped with an 8 1/4 inch rear differential. The clunking condition is due to an improper size brake drum pilot flange, which is machined on the axle shaft.

The outboard flange supports the wheel and the inner flange supports the brake drum. The outer flange measures 2.812-2.808 inches and the inner flange measures 2.832-2.826 inches. The inner brake drum pilot may be missing or not deep enough to support the brake drum. Without proper support, the brake drum may move during brake application, promoting the clunking condition. Jeep has a replacement axle (P/N 05018393AA) to eliminate the condition.

If the customer encounters the mentioned clunking condition during braking, remove the rear wheels and inspect the rear axle shafts. Attention should be given to the center pilot, which aligns the wheel and brake drum. Two separate pilot flanges are machined on the end of the axle shaft (see Fig. 4).
