# Tech Tip

FUEL 135

## FUEL QUALITY ISSUES

### Rough Idle and Misfire Following a Hot Restart

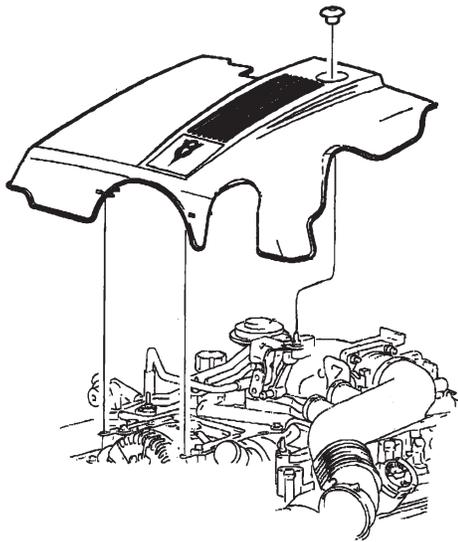
Fig. 1

Ford acknowledges that the 2005–2006 Crown Victoria and Lincoln Town Car vehicles used as taxis, limos and police cars may encounter an illuminated malfunction indicator lamp (MIL), with diagnostic trouble codes stored in memory, in addition to a rough idle condition following an extended idle. The symptoms are caused by vaporization of the fuel near injector #5. The following codes are usually stored in memory.

Engine Top Cover

If the mentioned trouble codes are stored and a rough idle and misfire is present on one of the mentioned Crown Vics or a Town Car, remove the engine top cover (see Fig.1) to allow for improved air circulation. Clear the codes, road test the vehicle and monitor the fuel pressure. If the codes reoccur, then you will have to continue with the code charts and misfire diagnostics. Most likely, the vehicle will run perfectly. The cover restricts the air flow over the engine, resulting in fuel vaporization near the #5 injector. Ford recommends leaving the cover off the engine. In 2006, Ford deleted the cover from production on the Crown Victoria. Also, they have included a new program calibration for the PCM.

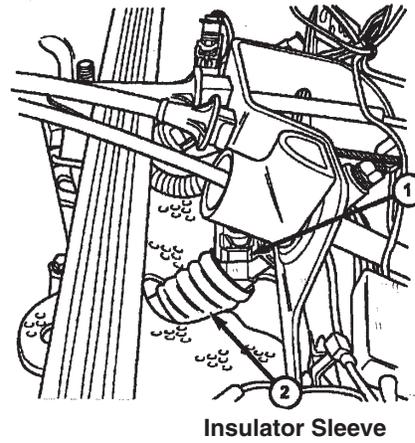
Fig. 2

#3 Injector

Insulator Sleeve

Owners of 2000–2004 Wranglers, 1999–2004 Grand Cherokees and 2000–2001 Jeep Cherokees equipped with the 4.0L engine may complain of a rough idle condition following a hot re-start. The condition and symptoms are more prevalent when the engine is allowed to heat soak for 15-20 minutes in ambient temperatures of 90 degrees F or higher. The conditions are characteristic of a town-driven or short trip-driven vehicle. The symptoms are more pronounced on vehicles that are burning fuel with a high ethanol content, such as a winter fuel being used in the spring or early summer months. Often the symptoms will accompany an illuminated MIL lamp and a stored PO303 misfire code, which indicates a misfire on cylinder #3.

According to the vehicle manufacturer, a vapor lock condition is occurring in #3 fuel injector. The heat from the exhaust manifold, following engine shut-down, vaporizes the fuel in the injector. The misfire will occur for approximately 30 seconds, until the vapor is purged from the injector. The cure is to install an ignition wire heat shield around the injector. Obtain an ignition wire shield (Jeep #56028371AA) from the vehicle manufacturer. Cut the shield or insulator sleeve in half, and make two insulator sleeves approximately 1 inch in length. Install one sleeve around #3 injector with the slit facing the upward side of the injector and install the other sleeve with the slit on the downward side of the injector. Make certain the sleeve is flush with the intake manifold and the injector connector is rotated to the 2 o'clock position from the driver's side of the vehicle (Fig. 2). This will minimize strain on the injector harness connector.
