## BRAKE AND SUSPENSION SOLUTIONS

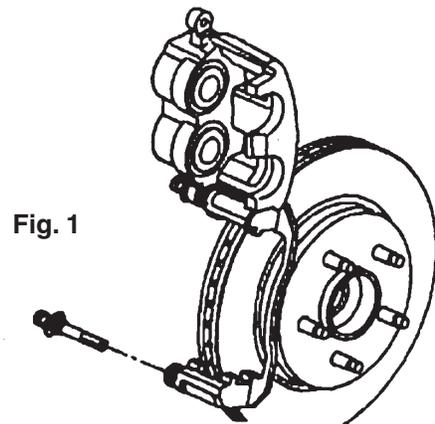
Fig. 1

Customer complaints of front-end rattling noises from owners of 2005–2006 Chevrolet Equinox, 2006 Pontiac Torrent and 2002–2006 Saturn VUE vehicles may be due to front caliper rattle. The condition is especially pronounced when the vehicles are driven on rough road surface conditions. To determine if the noise condition is caliper related, slightly apply the brakes when the noise is present. If this eliminates the symptom and the noise returns when the brakes are released, the lower bushings on the front calipers will require replacement.

- 1) Raise and properly support the vehicle (think safety).
- 2) Remove the wheel and tire.
- 3) Reinstall and tighten 2 lugs to secure the rotor to the hub.
- 4) With a large C clamp, compress the piston into the caliper bore, and remove the C clamp.
- 5) Remove the lower caliper guide pin bolt.
- 6) With the brake hose still attached, pivot the caliper upward and secure the caliper with mechanic's wire (see Fig. 1).
- 7) Remove the lower caliper guide pin, being careful not to damage the pin boot.
- 8) Remove the rubber bushing from the caliper guide pin (see Fig. 1).
- 9) Clean the caliper guide pin and install replacement bushing (GM #15824369). Lubricate the guide pin and bushing with high temp silicone brake lubricant.

- 10) Remove the support wire and rotate the caliper into position over the disc pads.
- 11) Install the lower caliper guide pin and torque to 32 ft. lbs.
- 12) Repeat the procedure on the opposite side.

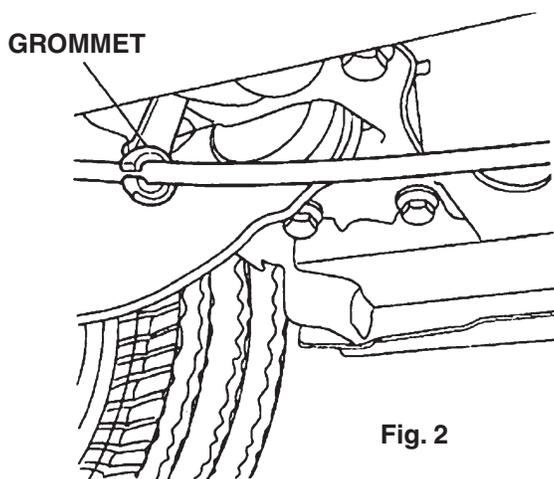
**Chevrolet Malibu Sedans...** Owners of 2005–2007 Chevrolet Malibu sedans equipped with rear drum brakes may complain of a squeak or creaking noise coming from the rear of the vehicle. The noise is more pronounced during slow speeds, and especially over bumps during wet conditions. GM says the condition may be caused by the parking brake cables rubbing or slip-sticking on their retainer grommet (see Fig. 2). The solution is to replace the existing white parking brake cable grommets with revised Teflon grommets (GM #15807015), which are black in color.
