# Tech Tip

FUEL SYSTEM 141

## THROTTLE BODY MAINTENANCE A System Clean-Up May Prevent Costly Repairs

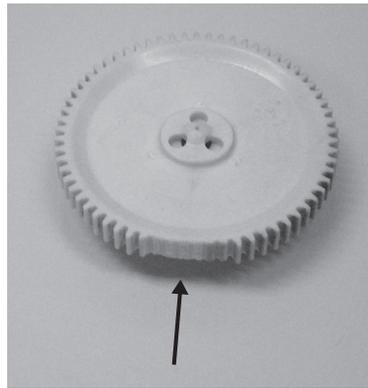
Detail of damaged plastic gear shown in Fig. 1

A system clean-up could have prevented the damage to the gear mechanism and saved the costly throttle body replacement.

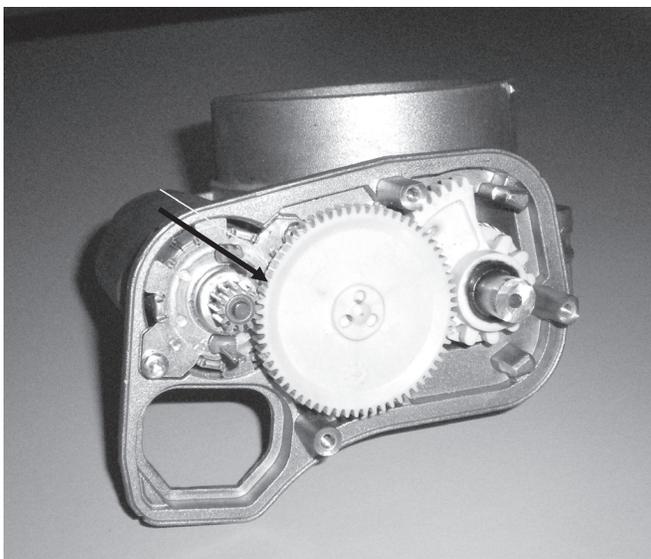
Contamination in the throttle bore can result in damage to the ETC system, requiring a throttle body replacement. The GM throttle body illustrated in Fig. 1 reflects damage incurred to the plastic gear that opens and closes the throttle plate, resulting from throttle bore residue. The component parts are not available, requiring a complete throttle body replacement at a cost exceeding three hundred dollars.

The system illustrated had been plagued with some driveability symptoms that reflected throttle bore
