Tech Tip

BELTS 142

ELIMINATING BELT NOISE Check for Factory Solutions!

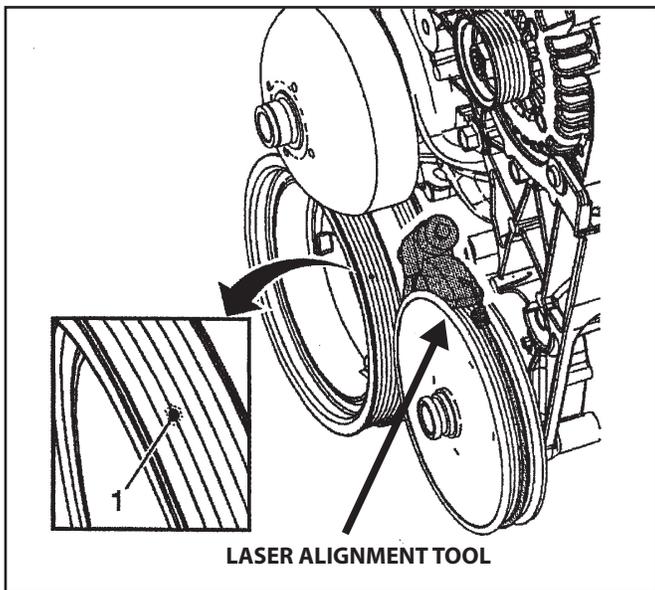
Many belt noise problems originate due to improper pulley alignment. The component that is most often the culprit is the power steering pulley. The power steering pulley is pressed onto the pump shaft and there is little margin for error in its placement, without affecting belt alignment.

To insure proper belt alignment, GM is currently recommending the use of a laser alignment tool to establish proper pulley

alignment on their 2009 and prior passenger cars and trucks (see illustration). GM recommends the Kent-Moore EN-49228 Laser Alignment Tool. The laser tool makes the pulley alignment process more precise, and will reduce comebacks and warranty repairs due to accelerated belt wear, slippage, and belt noise complaints. Instructions are included with the laser kit to insure proper set-up and alignment. Other tool equipment companies offer similar laser alignment tools. Make certain you follow all safety precautions including: don't look directly into the laser beam, do not shine the laser on a highly polished or reflective surface and don't point it at a fellow technician. Always use laser safety glasses when using the equipment.
