Tech Tip

LUBE SERVICE 143

LUBE SERVICE SOLUTIONS It May Require a Factory Fix

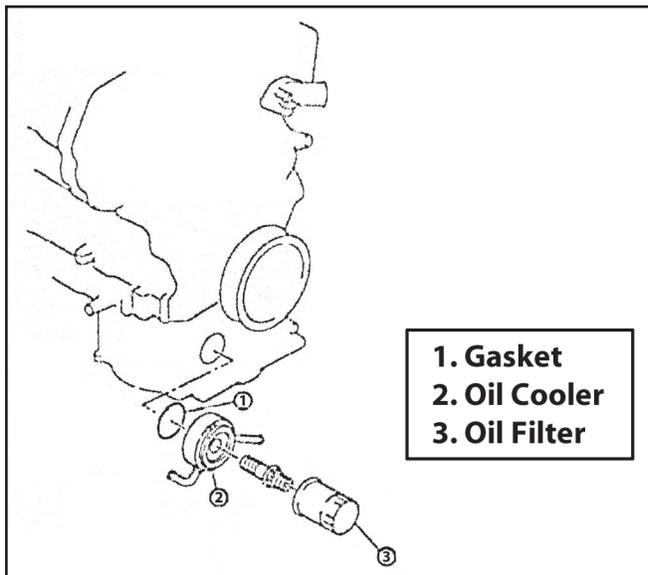
FIG. 1

Chances are the leakage had nothing to do with the oil filter. Most likely, the oil leakage is coming from a rubber gasket positioned behind the oil cooler (see Fig.1). The vehicles that are affected include: 2004 Quest, 2000–2006 Maxima, 2003–2006 Murano and 2002–2006 Altima vehicles equipped with a VQ30

or VQ35 engine. The inspection should begin with cleaning the oil cooler, oil filter and the surrounding area and allowing it to dry thoroughly. Run the engine and closely examine the oil filter, oil cooler and the area directly behind the oil cooler. If seepage is coming from the oil cooler gasket, a replacement gasket is available from Nissan (P/N B1304-43U00).

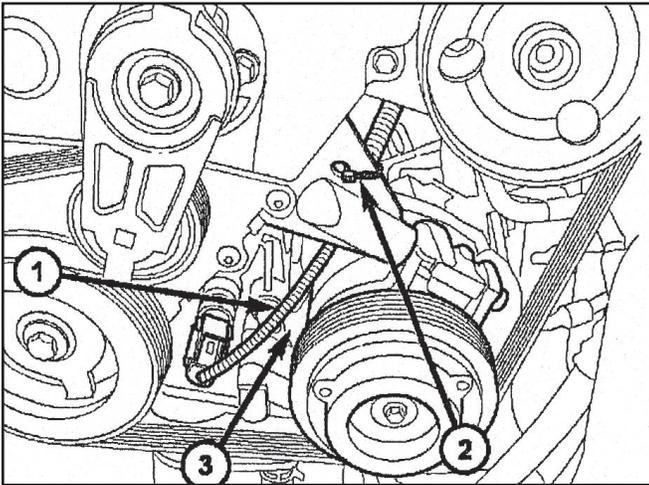
FIG. 2

Complaints of an intermittent or constantly illuminated oil pressure lamp from owners of 2007 Chrysler 300, Charger and Magnum vehicles may be due to a damaged oil pressure switch harness.

OIL PRESSURE SENSOR HARNESS

- 1. Oil Pressure Switch Harness**
- 2. Tie Strap**
- 3. 20 mm (3/4 inch) Clearance to the A/C Compressor Pulley**

If the customer complains of an illuminated oil pressure lamp, examine the oil pressure switch harness in the area of the A/C compressor pulley. If the pulley has made contact with the harness, the harness should be rerouted and secured with a tie strap (see Fig. 2). For liability reasons, always verify that the engine has sufficient oil pressure.
