Tech Tip

BRAKES AND SUSPENSION 150

TROUBLESHOOTING SOLUTIONS For Some Elusive Brake and Suspension Symptoms

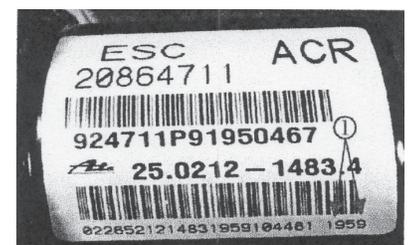
ILLUSTRATION 1

When the brake pedal encounters a spongy pedal sensation, increased pedal travel and increased effort to stop, aerated fluid is the likely culprit. We have all encountered these symptoms and experienced the frustrations that can go with removing the air from the system. In some cases the technician may bleed the system and return the pedal height and feel to normal, only to encounter recurring symptoms. Some basic checks should be performed to include the level of the fluid in the master cylinder and for any external fluid leaks. Bleeding the system can be a challenge, as some ABS systems may require a scan tool to properly purge the air from the system. Check the factory service bulletins for information pertaining to recurring low or spongy pedal conditions. The problem could be in the design of the system or a defect with one of the ABS components. GM has addressed a recurring spongy brake pedal sensation on the following vehicles equipped with RPO JL4 (Active Brake Control) only:

Cause: GM acknowledges that the condition is caused by an accumulation of air in the master cylinder or due to a missing filter in the brake pressure modulator valve (BPMV).

Correction: GM recommends inspecting the label on the brake pressure modulator valve, paying special attention to the 4-digit number positioned beneath the bar code to the far right (see illustration 1). If the 4-digit number is one of the following (2428, 2438, 2448, 2458, 2468,

2478, 2488, 2498), the BPMV must be replaced and the system filled with brake fluid and properly bled, utilizing a scan tool to perform the ABS automated bleeding procedure.
