FACTORY BRAKE SOLUTIONS For Some Loss of Brake Pedal Concerns

IMPROPERLY FORMED OR MISSING BRAKE BOOSTER CLIP

NISSAN BRAKE PEDAL INSPECTION

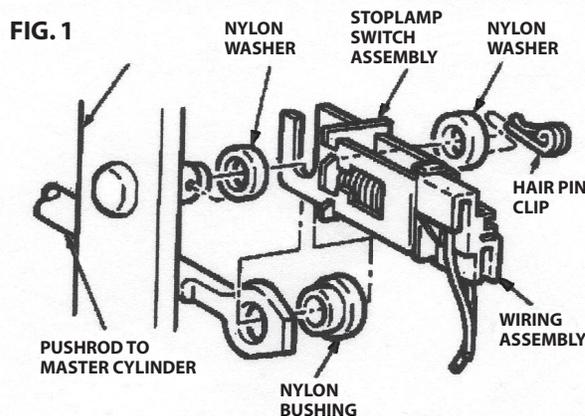
The truck was a recent purchase and someone had replaced the power brake vacuum booster in what turned out to be a botched installation. On this Ford truck, the stoplight switch shares the same brake pedal pin as the input rod to the vacuum booster (see Fig. 1).

Someone had improperly installed the assembly, which incorporates bushings, washers and a stop

light switch secured by a hair pin clip. The clip that keeps the assembly secured to the brake pedal pin had been damaged during installation, and it was found on the floorboard. The clip had dislodged, allowing the vacuum booster input rod to detach from the brake pedal. When this occurred, the brake pedal hit the floor during brake application without any means of applying hydraulic pressure to the brakes.

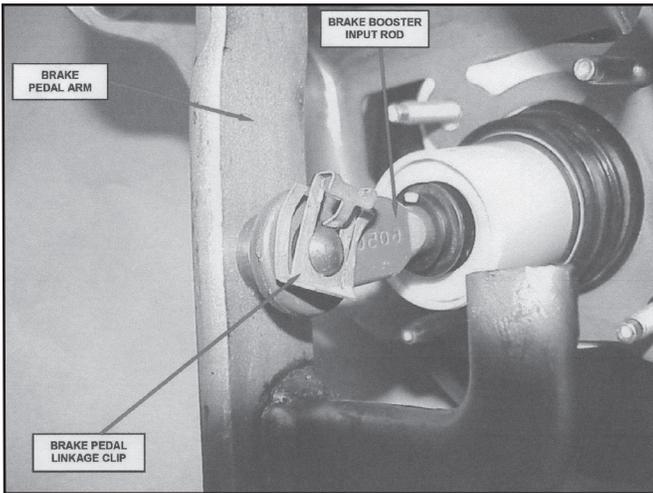
FIG. 2

Chrysler reports that an improperly formed, missing or detached brake booster input rod clip could result in a brake failure without warning. Chrysler's action involves replacing the clip on all vehicles mentioned except the Dodge Ram trucks. Chrysler Safety Recall J37 (NHTSA #10V009000) identifies specific vehicles and production dates that may have been manufactured with an improperly formed or missing brake booster input rod clip. Vehicles already inspected and repaired, as determined by the warranty records, were excluded from this notice. Approximately 20,000 of the mentioned vehicles may have incorrectly manufactured clips. The mentioned Dodge Ram trucks would be inspected for the presence of the clip, as some were left off during assembly. Trucks identified without

the clip must have a new clip installed. When the clip is properly secured it will make an audible click when attached (see Fig. 2, Courtesy of Chrysler).

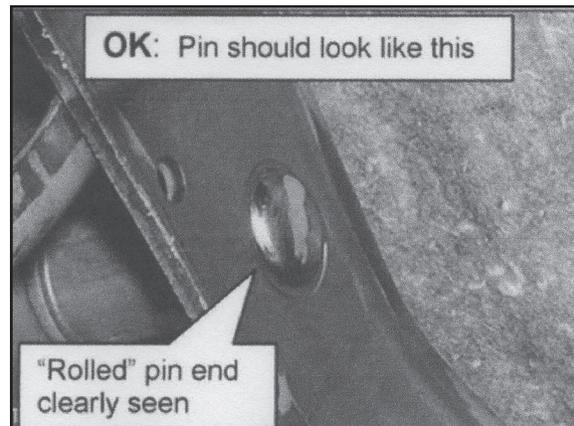
FIG. 3

According to Nissan, the end of the pivot pin was not spin-formed to specification during the manufacturing process of the brake pedal assembly. It is possible for the pivot pin to slide from its

proper position, causing the brake pedal to partially disengage from the brake pedal bracket. When this occurs, the brake pedal will be loose, causing a reduction in pedal stroke, which could result in a crash.

It may be necessary to reposition a wiring harness to get a good visual inspection of the pivot pin. Inspect the pivot pin on the right hand or inboard side of the brake pedal bracket (see Figs. 3 & 4, Courtesy of Nissan). The pivot pin on a good assembly should reflect a rolled end as illustrated in Fig. 3. If the pivot pin reflects a square end as illustrated in Fig. 4, the brake pedal assembly must be replaced to prevent the pedal from detaching from its mounted position.
