Tech Tip

Lube Service 171

LUBE SERVICE TIPS Identifying Inherent Problems

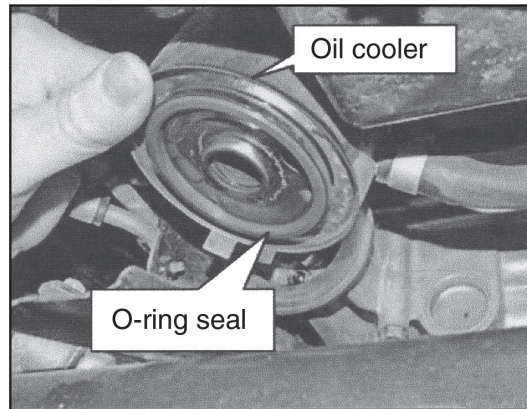
Illustration 1

The oil cooler leakage condition is most likely due to a bad oil cooler O-ring seal. The applications that are most susceptible to leakage include: 2004–2006 Quest, 2000–2006 Maxima, 2003–2006 Murano, and 2002–2006 Altima, equipped with the VQ30 (3.0L) and VQ35 (3.5L) engines.

Examine the oil cooler for evidence of leakage. A thorough clean-up may be necessary to pinpoint the source of the

leakage. Fluorescent dye and a black light can be beneficial, but seldom necessary. Once the area is clean, run the engine and observe for leakage behind the cooler. If oil is seeping from behind the cooler, a revised O-ring seal (Nissan #B1304-43U00) will be necessary to stop the leakage (see illustration 1). Applications newer than those illustrated are not susceptible to leakage, as they are equipped with the revised O-ring.

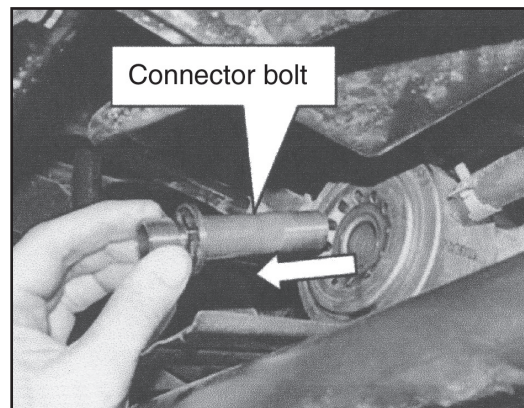
Illustration 2

Nissan has recalled certain production vehicles including: 2011–2012 Nissan Frontier, XTerra, Pathfinder and Nissan NV vehicles. They have determined that some of the bolts that secure the oil cooler to the engine were manufactured below specification strength. The bolts may break at the oil filter attachment point, promoting oil leakage (see illustration 2). Dealers and vehicle owners have been notified.
