# Tech Tip

AIR FILTERS 174

## AIR FILTER RESTRICTIONS Due to Snow and Water Related Conditions

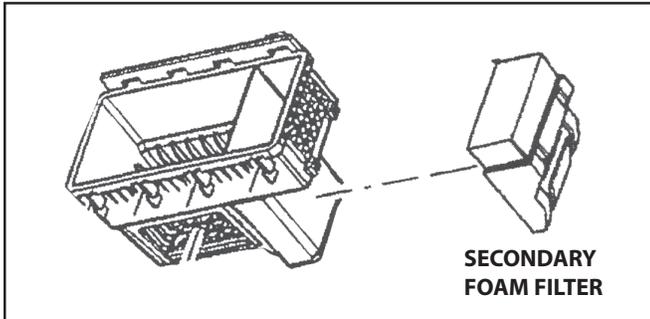
The mentioned applications equipped with the 6.7L diesel engine may encounter a loss of power due to snow accumulating in the air cleaner, restricting the air flow.

This condition often occurs when the vehicle is operated in extreme snow conditions and especially with those applications that are equipped with a snow plow. When the condition is present, trouble codes P0299 (Turbocharger Underboost) and P1247 (Turbocharger Boost Pressure Low) may be stored in diagnostic memory. Ford recommends the installation of new design low restriction secondary foam filter (Part # BC3Z-9601-D) to alleviate the symptoms (see illustration).
