Tech Tip

OIL FILTERS 180

CHRYSLER'S 3.6L PENTASTAR ENGINE With Oil Filter Housing Leakage

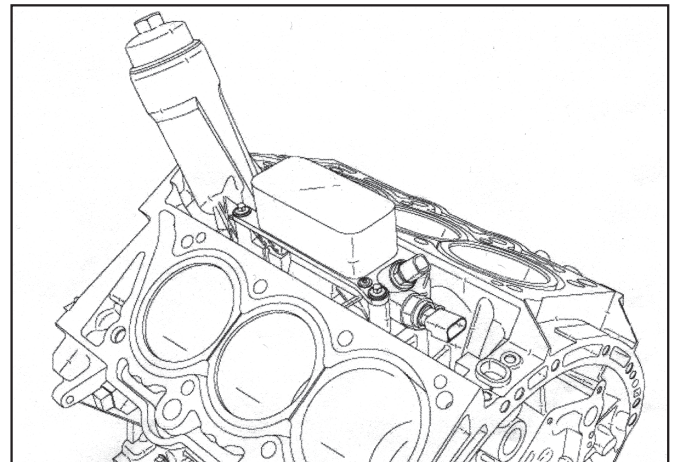
ILLUSTRATION 1

Examining the oil filter housing assembly and considering its location makes it obvious that leakage could easily occur. The plastic oil filter housing and cooler assembly is positioned

beneath the intake manifold between the cylinders (see illustration 1), which is often referred to as the valley of the engine block. This area may hold a quart of oil before displaying any signs of leakage. This can result in the technician missing an oil leak condition following his lube service leak check inspection.

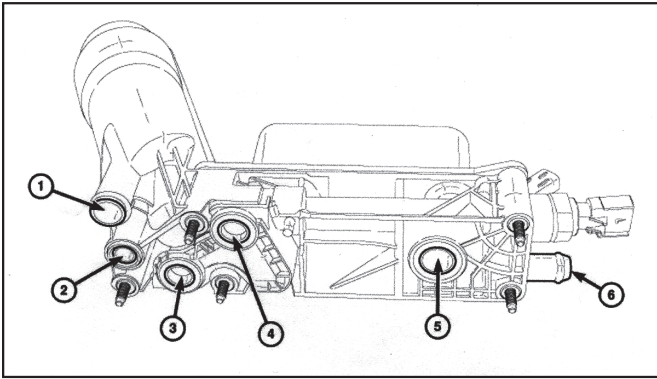
ILLUSTRATION 2

The engine oil pump supplies oil to the oil filter housing inlet (1) to the oil filter element located within the housing (see illustration 2). The oil is filtered and then travels internally through the oil cooler and then to the main oil gallery (5). The oil filter by-pass is built into the housing and is not serviceable. Removing the oil filter cap from the housing allows oil to drain from the oil filter cavity into the crankcase (2).

Coolant flows from the right cylinder block water jacket (3) and from the left cylinder block water jacket (4) into the housing. The coolant flows through the oil cooler and exits the housing from

the rear hose nipple (6) and is returned to the water pump. A coolant by-pass in the housing is designed to direct excessive coolant flow around the oil cooler for continuous circulation (Illustration and description courtesy of Alldata). A lot of oil and coolant pass through the housing and O-rings. Any disturbance of the O-rings or a cracked housing can promote leakage.

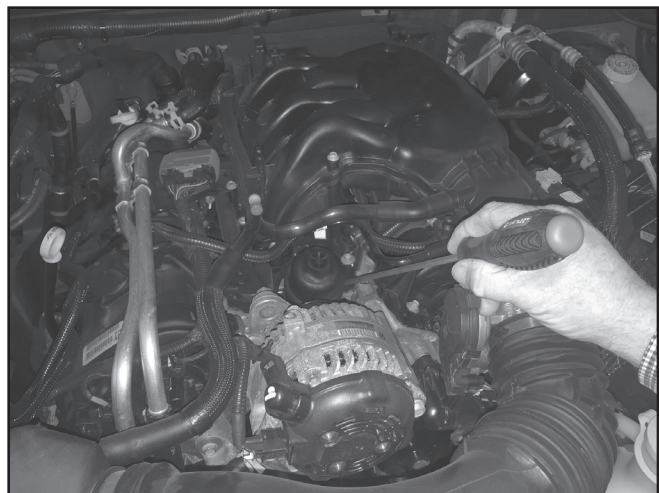
ILLUSTRATION 3

To check for oil pooling in the engine valley... fabricate a dipstick (a wood stick will better display the presence of oil and the depth) and insert the stick next to the oil filter housing and allow it to bottom out in the engine valley (see illustration 3). If oil is pooling in this area, the oil filter/cooler housing will most likely require replacement. A small amount of oil (wetness) on the tip of the fabricated dipstick may be the result of spillage when changing the oil filter and should be no cause of concern.

The presence of oil pooling in this area calls for an immediate discussion with the vehicle owner prior to performing a lube service. If the customer is not receptive to having the housing replaced, make certain you document your recommendation on the repair order and retain a copy for your records. We have read reports of vehicles encountering fires due to oil leakage from the oil filter housing.
