# Tech Tip

BRAKES 182

## BRAKE AND SUSPENSION SOLUTIONS For Some Difficult to Diagnose Symptoms

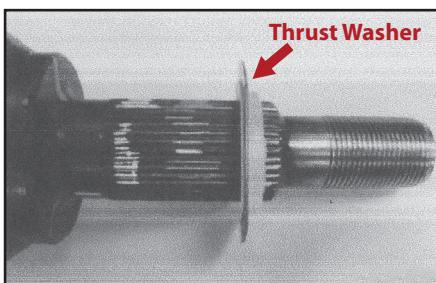
Customer complaints of a clicking or popping noise from the front wheels on 2011-2014 Ford Flex, 2011-2015 Explorer, Taurus and 2011-2014 Lincoln MKS and MKT vehicles may occur when accelerating from a stop, during turns, or when shifting between drive and reverse.

- 1) Separate the half-shaft from the wheel hub.
- 2) Do not remove the half-shaft from the transmission or the power transfer unit.
- 3) Install a thrust washer (Ford # BB5Z-7G273-B), metal surface first, over the half-shaft splines until the metal ring is flat against the wheel bearing mating surface (see illustration). The nylon surface of the thrust washer should face outward toward the hub/splines, as illustrated.
- 4) Install the half-shaft to the wheel hub.

This procedure will eliminate the movement, which causes the clicking, popping noises previously described.
