LOW OIL PRESSURE MESSAGE Locating the Mystery Filter

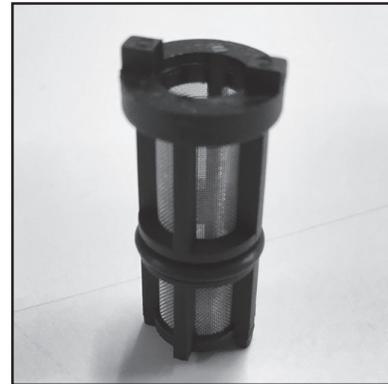
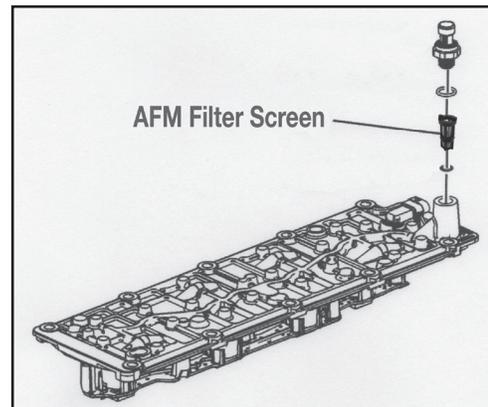
AFM Filter Screen

When the mentioned filter screen becomes restricted with debris/sludge, it restricts the oil supply to the oil pressure sensor, resulting in a low oil pressure warning/message. The screen (see illustration) is actually a filter for the valve lifters on those GM applications equipped with AFM. The purpose of the filter screen is to help control contamination that can affect the AFM hydraulic system by filtering the oil that flows through the valve lifter oil manifold and its related solenoids.

equivalent and the oil pressure parameter is low but the oil pressure is normal at the oil filter housing, inspect the AFM valve lifter oil filter screen (located beneath the oil pressure sensor) for evidence of sludge. A contaminated filter screen can restrict the oil flow to the oil pressure sensor. If the filter screen is plugged, it can be cleaned with brake cleaner and low air pressure. Most elect to replace the filter screen, as it is a low cost item. I just purchased one for \$6.57. Replacement of the filter screen can be performed without removing the intake manifold, as recommended by the vehicle manufacturer. It will require some basic tools such as a ratchet, socket, short extension, wiggle joint, patience, band aids and forgiveness for some of the comments that you will make during the exercise.
