## DIAGNOSING ENGINE MISFIRES

### Would You Have Considered Engine Coolant or Oil Leaks?

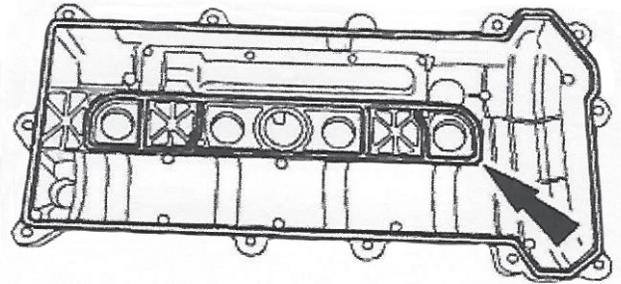
The Ford Ranger equipped with a 2.3L engine would repeatedly encounter a misfire condition on the same cylinder. Each time, the technician would remove the spark plug and observe a spark plug and spark plug wire boot totally encapsulated with oil. He was convinced that a major engine problem was the reason for the presence of the oil. Later it would be determined that a defective valve cover gasket was the cause of the oil drenched components and the misfire symptom.

They are shielded from oil by an internal valve cover gasket (see Fig. 1). If the gasket fails to properly seal, oil will pool in the leaking cavity, shorting out the spark plug on that cylinder. A new valve cover gasket will restore the firing on that cylinder and will prevent a recurring event.

**Fig. 1 - Internal Valve Cover Gasket**

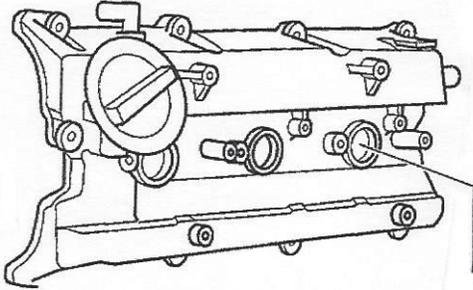
The oil leakage had progressed to the point of seeping into a spark plug tube, shorting out a spark plug, resulting in a misfire condition. The repair would require new valve covers to eliminate the leakage. The reason is the grommets that seal the spark plug tubes are not a replacement item and can only be obtained through the purchase

of new valve covers (see Fig. 2). Even if they were available as a replacement item, most Nissan techs would recommend replacing the valve covers, as the plastic covers have a history of warpage or cracks from the intense heat. This is a labor-intensive repair and certainly not a job that you want to do over, at the shop's expense.

**Fig. 2 - Non Replaceable Grommets**
