TECH TIP

LUBE SERVICE 205

DODGE AND JEEP OIL FILTER IDENTIFICATION

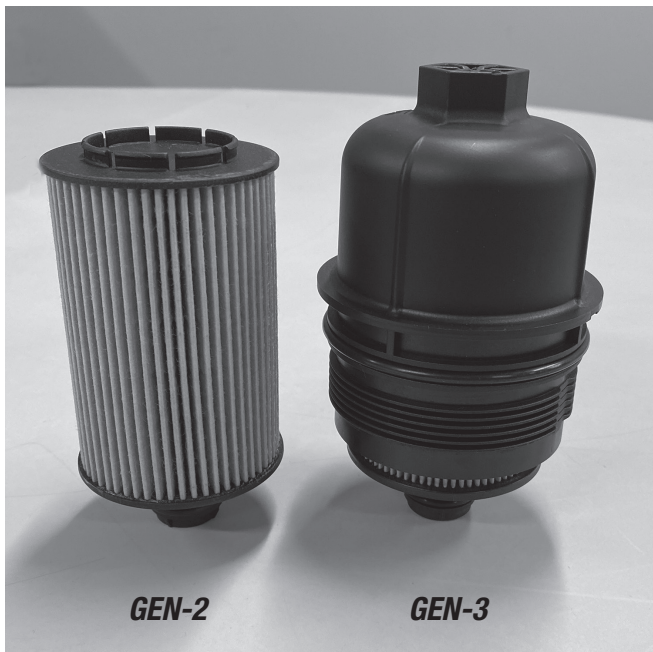
The filters GEN-2 and GEN-3 are different in design and installing the incorrect filter can result in premature engine failure.

The DT and JL vehicles (see above code) require the GEN-3 style filter, while the DS and WK vehicles require the GEN-2 style filter (see filter illustrations).

Vehicles equipped with the GEN-3 3.0L engine may encounter an illuminated Malfunction Indicator Lamp (MIL) if the oil filter cap is not tightened to 18 ft. pounds (221 inch pounds). Trouble code P0524 may also be stored in memory on the DT and JL vehicles due to an improperly tightened cap.

The GEN-3 design filter is designed to be replaced as an assembly. Do not remove the filter from the cap, as damage to the filter or cap can result in engine damage.
