# TECH TIP

ELECTRICAL 220

## DIAGNOSING ELECTRICAL PROBLEMS

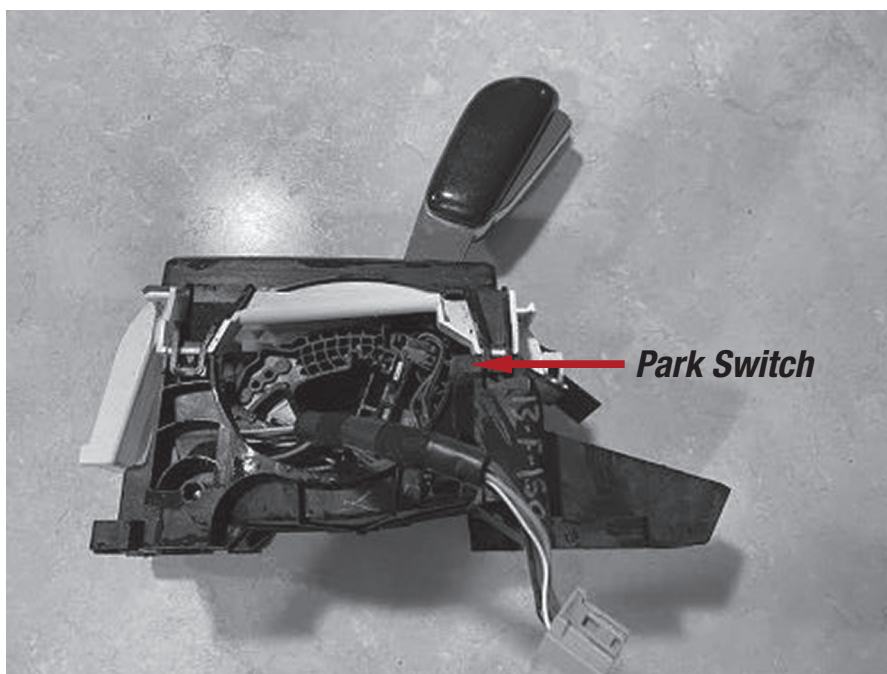
The culprit for the lamp continual illumination was a defective park position switch located in the floor shifter assembly (see illustration). The body control module was waiting on the park position switch signal to time out and would then extinguish the instrument panel lamps. In addition to continuous illuminated instrument panel lamps, a defective park position switch can be confirmed by observing the gear selector in the dash. With the ignition switch in the on position the park indicator (P) should be illuminated when the gear selector is in the park position. If it is not illuminated, the park position switch is likely defective. The plunger in this small switch takes a constant pounding when the shifter is placed in the park position and the

shifter lock is released. This switch is not a replaceable item from Ford, requiring a replacement of the complete shifter assembly in a cost range of approximately \$600 for the part, plus labor. Vehicles affected include 2011-2014 F150 trucks. The good news is...the switch is available from the aftermarket.

The switch can be replaced without removing the shifter from its mounted position. Obviously, the shifter console upper trim panel will have to be removed to gain access to the switch. Purchase a brand name switch such as a Dorman 905-026. Our first encounter was with a no-name brand switch, which resolved the lamp illumination but would not allow the ignition key to be removed from the ignition key lock assembly.
