# Tech Tip

DIESEL SERVICE 166

## DIESEL SERVICE It Can Be a Challenging Event

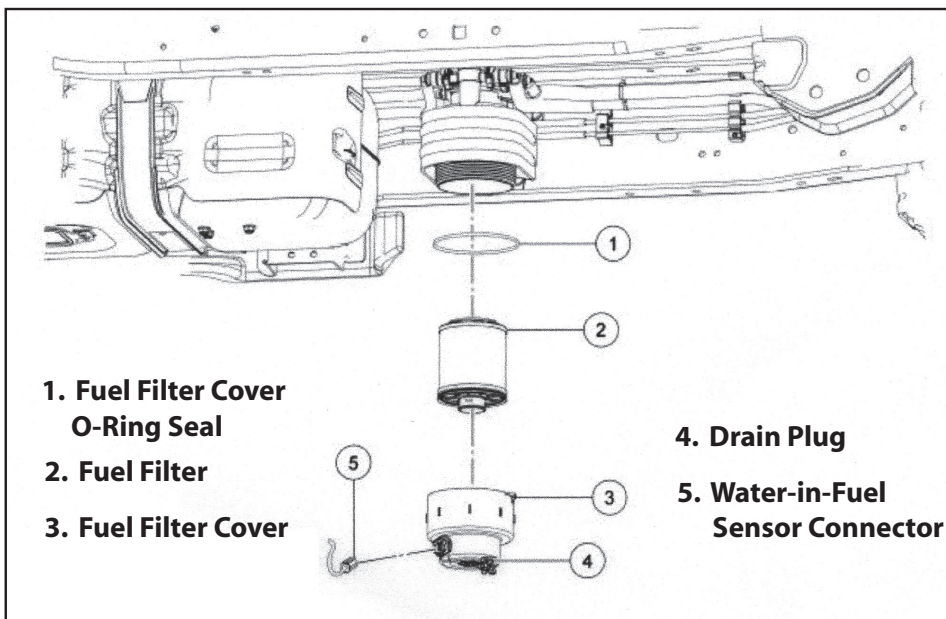
**Fig. 1: Fuel Conditioning Module Mounted Filter**

Ford has addressed this problem in a recent service bulletin. They advise that some 2011–2012 F-Super Duty vehicles equipped with a 6.7L turbo diesel engine may run rough, fail to start, or encounter trouble codes P1291 or P1292 due to shorted fuel injectors. This condition has been traced to diesel fuel being contaminated with DEF fluid or fuel that has gelled.

To determine if DEF has been installed in the fuel system, remove the fuel conditioning module filter (see Fig. 1). Allow the filter, filter bowl and cover to dry for a minimum of two hours. After that period of time examine the mentioned components for the presence of a white powdery residue. If these deposits are present, the complete high pressure fuel system and diesel fuel control module will require replacement and the fuel system will have to be drained and flushed. If the mentioned codes were present, examine the engine wiring harness for chafes near the EGR cooler. If no damaged wiring is present, Ford recommends disconnecting each fuel injector for the mentioned codes P1291 (injectors 1, 4, 6, 7) and P1292 (injectors 2, 3, 5, 8). Check for continuity between the injector electrical pins and the injector body. If continuity is present, replace all eight fuel injectors and the injector return hose.

Obviously, if you encounter one of these vehicles with an engine performance related symptom or the mentioned codes stored, you must make a thorough inspection. Replacing the fuel filter will not satisfy the symptoms. If the fuel system has been subjected to DEF, document any evidence of the mentioned residue on the repair order.

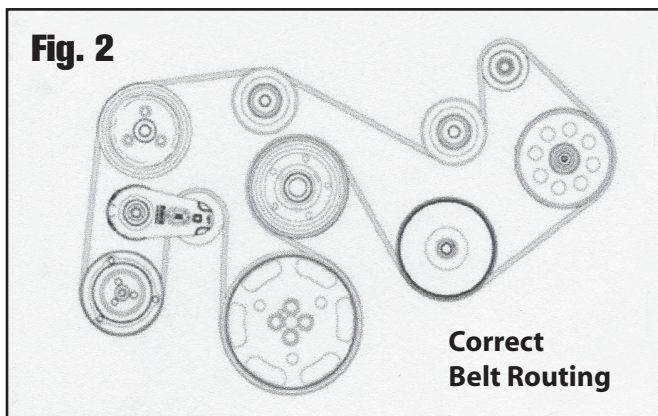
The problem stems from the improper routing of the belt at the upper idler pulley. The belt must be routed over the upper idler pulley (see Fig. 2). If the belt is placed

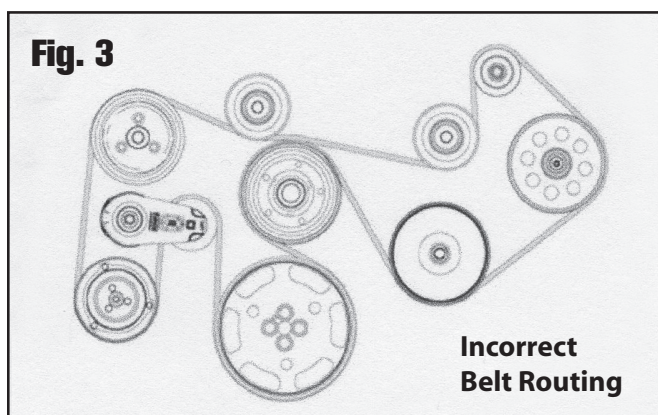
beneath the idler pulley as illustrated (see Fig. 3), then belt-to-belt contact will occur, resulting in noise and premature wear.

Claims of premature belt wear have been reported on 2011 Ford F-Super Duty trucks equipped with the 6.7L turbo diesel engine, including some early production 2012 models. The accelerated wear
