Tech Tip

BRAKES AND SUSPENSION 150

TROUBLESHOOTING SOLUTIONS For Some Elusive Brake and Suspension Symptoms

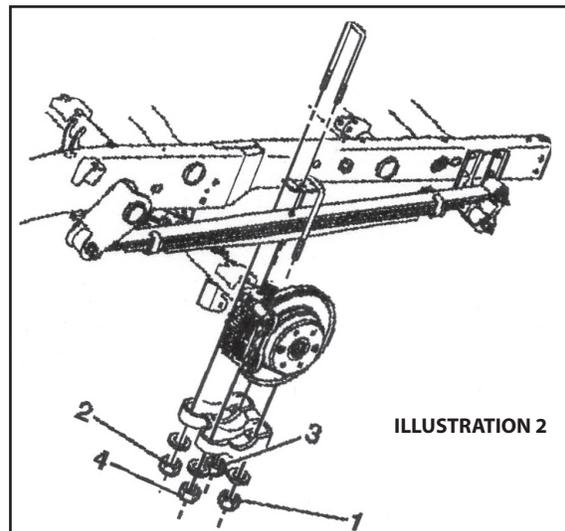
GM states that if lubricating the leaf springs fails to eliminate the noises on 1500 Series trucks built prior to October 2004, it could be caused by an incorrectly dimensioned splay clip (the band holding the ends of the leaf springs together) that interferes with the leaf springs. A wider splay clip was introduced in early 2005 to provide additional clearance. To correct this concern will require replacing the rear leaf spring assembly.

The procedure is simple.

- 1) Support the vehicle at curb height when making the leaf spring torque adjustments.
- 2) The following components should be loosened:
 - a) The shackle joint to the frame.
 - b) The front eye joint to the frame.
 - c) The rear eye to shackle joint.
 - d) The anchor plate U-bolts.
- 3) Re-torque the shackle joint to the frame and to the rear eye. Tighten the shackle nut to 73 ft-lb.
- 4) Re-torque the anchor plate U-bolts (see illustration 2). Tighten nuts 1, 2, 3, 4 to 74 ft-lb.
- 5) Re-torque the front rear spring mounting nut. Tighten to 148 ft-lb.
- 6) Repeat steps for opposite side leaf spring assembly.
